**Remedial Action
Construction Summary Report**

**Combined Sheet Pile and Soil-Bentonite
Barrier Wall**

**McCormick & Baxter
Creosoting Company
Portland, Oregon**

April 2004

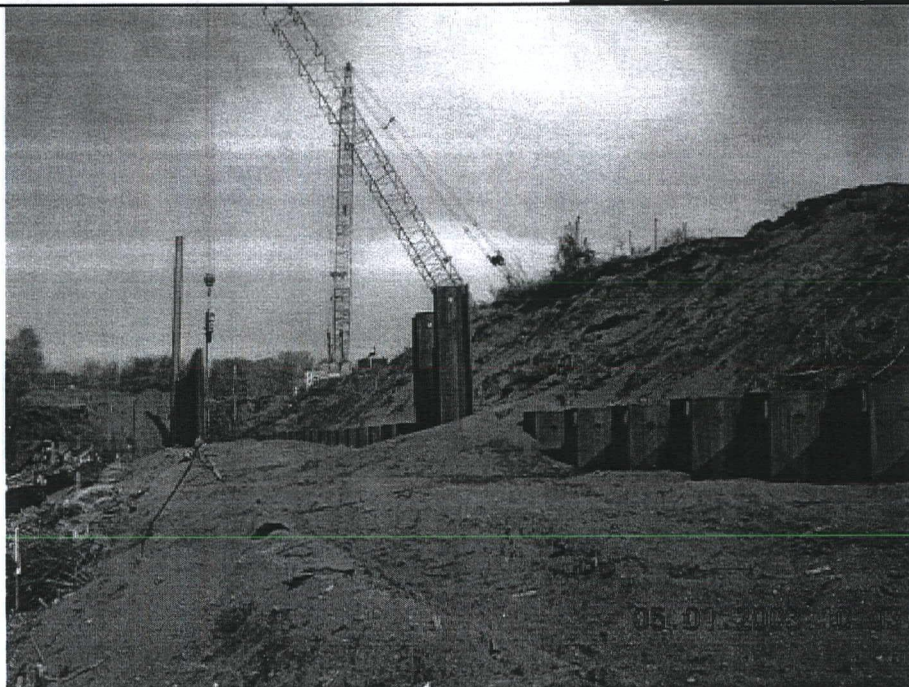
Photo 22 View of bank erosion at southeast bank.
Direction: Northwest

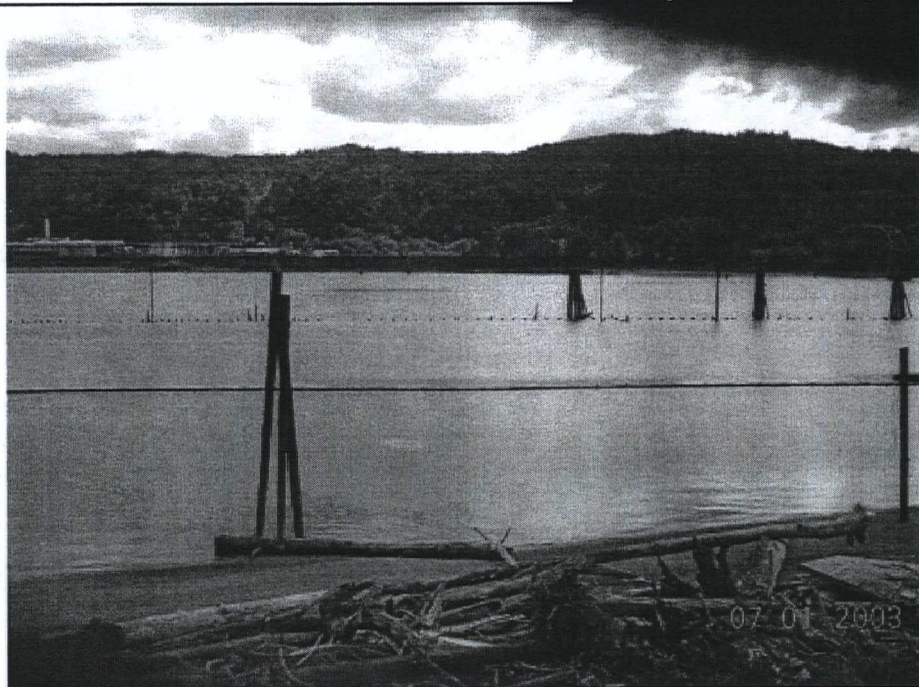
- **6/16/03** - Sheet pile installation continued today under a change order condition. Remtech attempted to bypass a refusal area near tie-in (Alternative #1). NOAA, EPA, and DEQ observed sheen NAPL globules rising from the river bottom that create sheen on the river surface. The sheen was approximately 50 yards southeast of the end of the bulkhead.

Photo 23 Observed sheen in water.
Direction: West

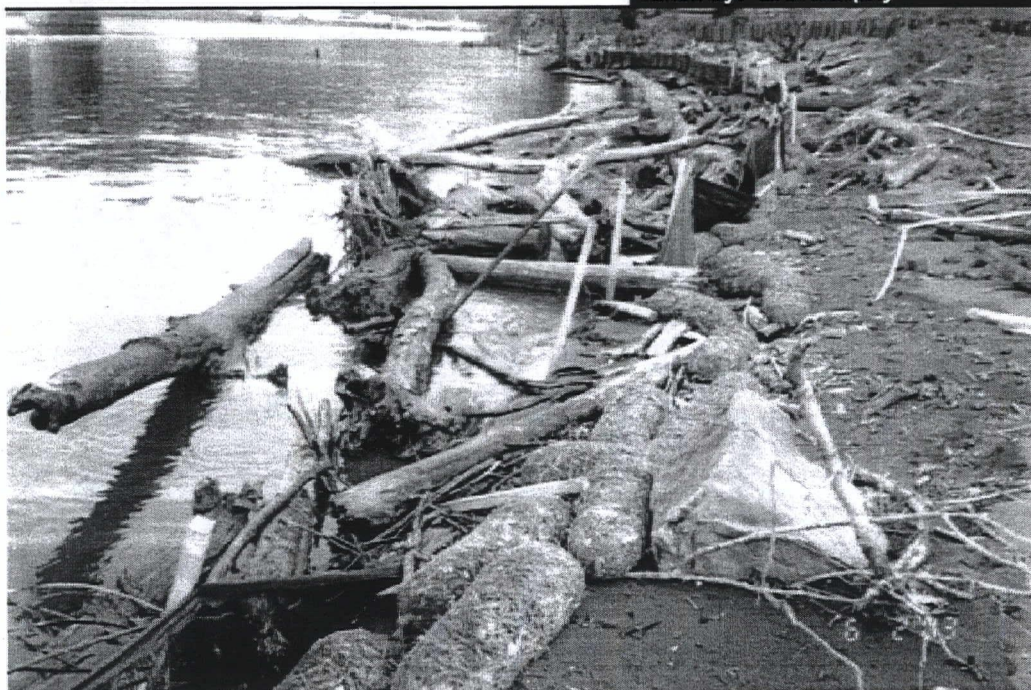
Photo 24 Silt fence and bio-bags on northwest beach after a high water event.
Direction: Northwest

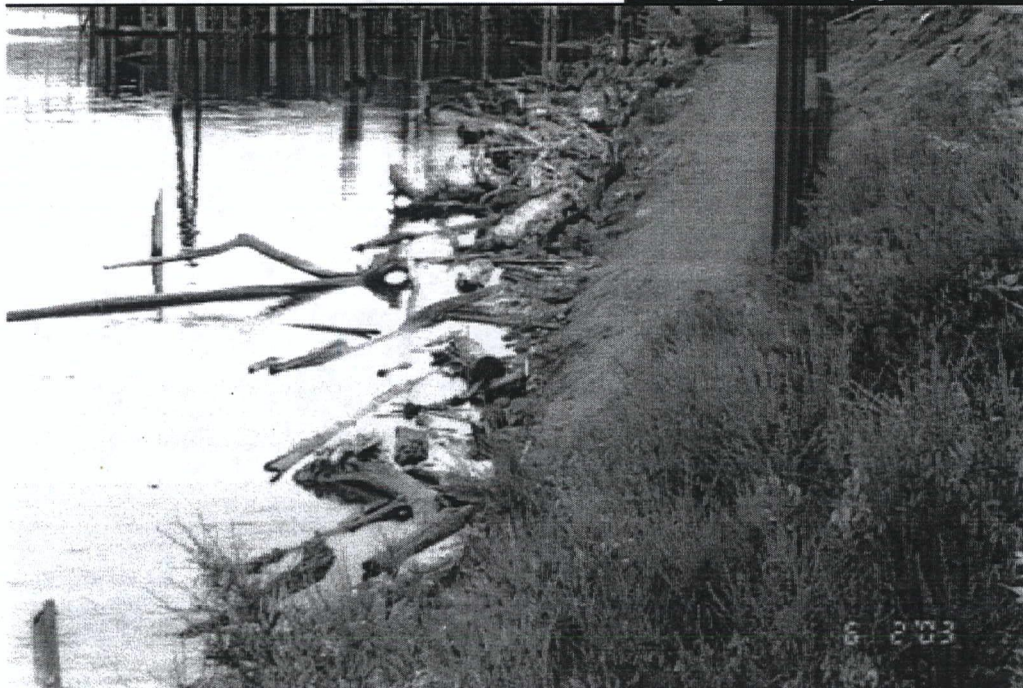
Photo 25 Silt fence and bio-bags on southeast beach after a high water event.
Direction: Northwest

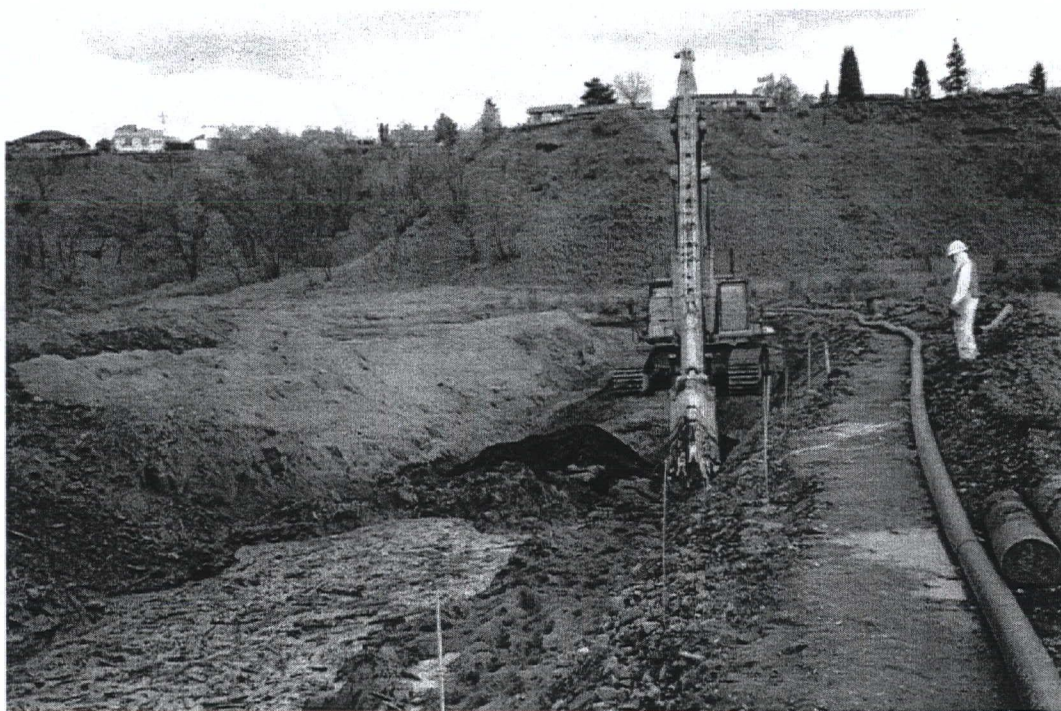
Figure 4. View to the east of the northeast portion of the slurry trench in progress. Woody debris can be seen in the trench in the foreground.

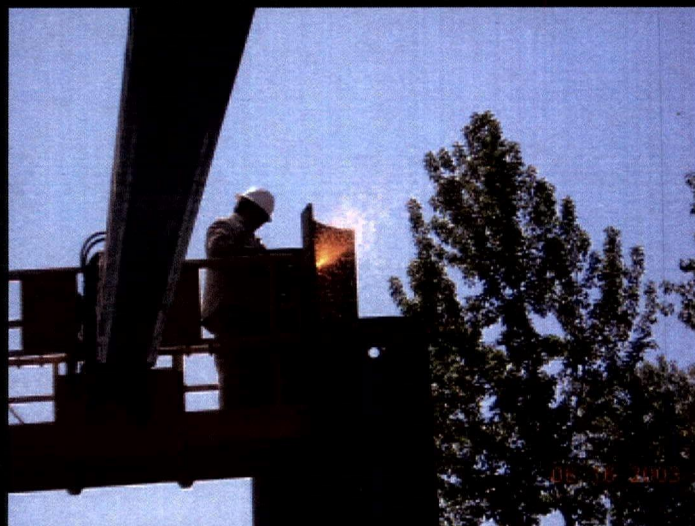
- **5/6/03** - Multiple refusals encountered during sheet pile driving. Refusals were varied lengths, and hard driving was noted on all 80-foot sheets. Occasionally, the sheet piles were heating up, fatiguing, and failing around the jaws of the hammer.

Photo 47 Torching off the top of a sheet after a fatigue failure during hard driving.
Direction: West

E & E recommends that the refusal areas (windows) in the sheet pile barrier wall be patched using a pressure grouting technique. Pressure grouting is the in-situ creation of cemented soil geometries (soilcrete). The cost and effectiveness is highly dependant on in-situ soil (grain size distribution) encountered and the physical characteristics required (permeability). The recommended grouting consists of installing pressure grout columns, 4-feet in diameter at a minimum, centered on the 1/2 pairs (sheets) that have met with refusal. Cost estimates range from \$75,000 to \$125,000, and the estimated time for implementation is two to three weeks.

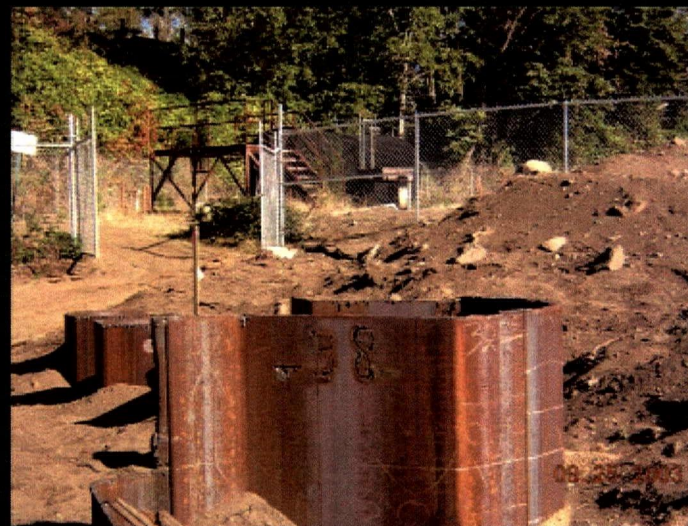
Photo 48 Refusal sheet with tip elevation torch-cut into it (FWDA).
Direction: North
